Forensic Building Science, Inc.

Insured: Memorial Inn & Suites
Property: 9535 Katy Fwy
Houston, TX 77024
Home: 123 Main St.
Saint Paul, MN 55105-3529

Type of Loss: Hurricane

FIELD REPORT FOR INITIAL STORM DAMAGE INVESTIGATION

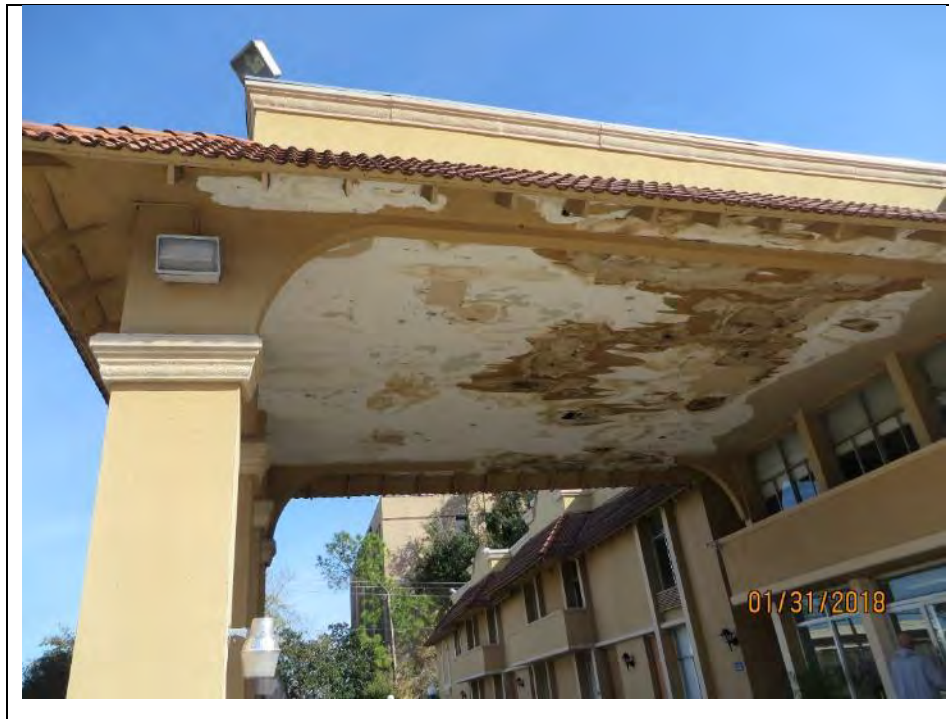
Figure 03. Water damage on Portico (KJS)

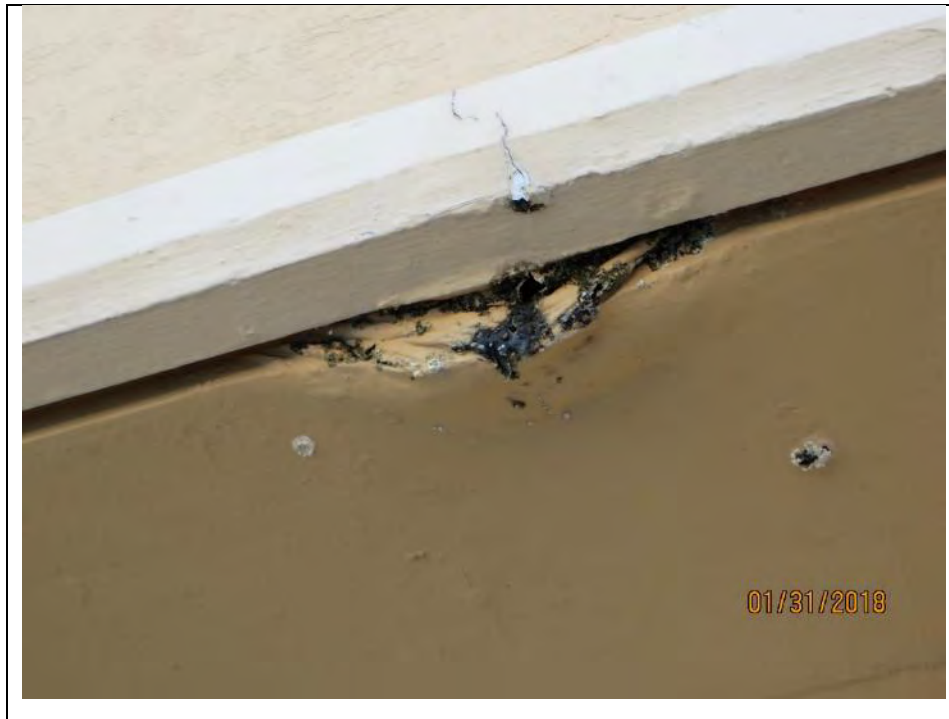
Figure 17. Water damage (KJS)

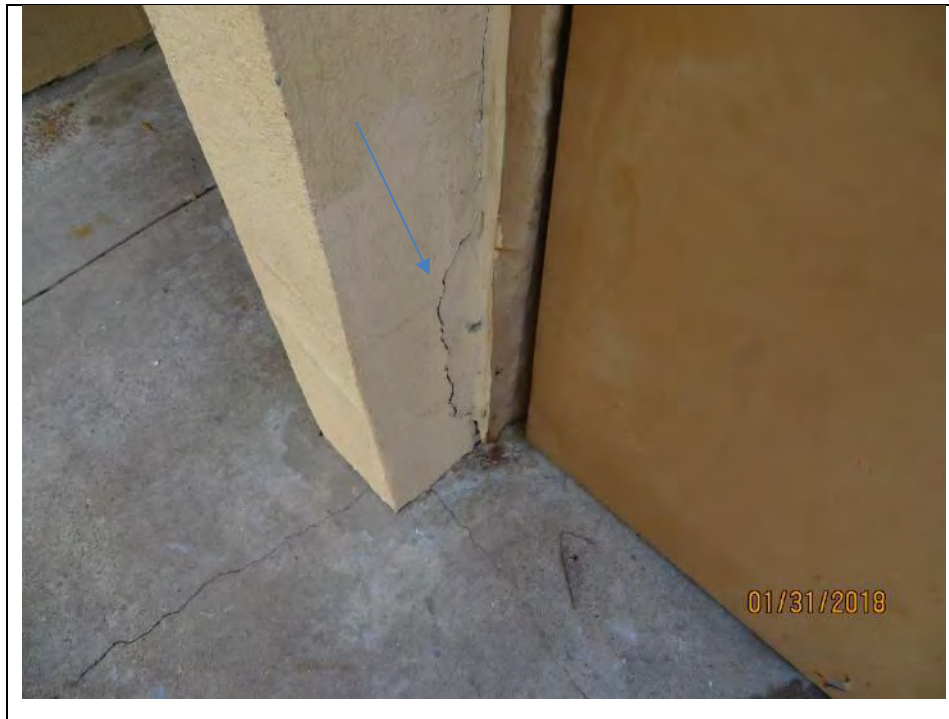
Figure 21. Fresh crack (KJS)

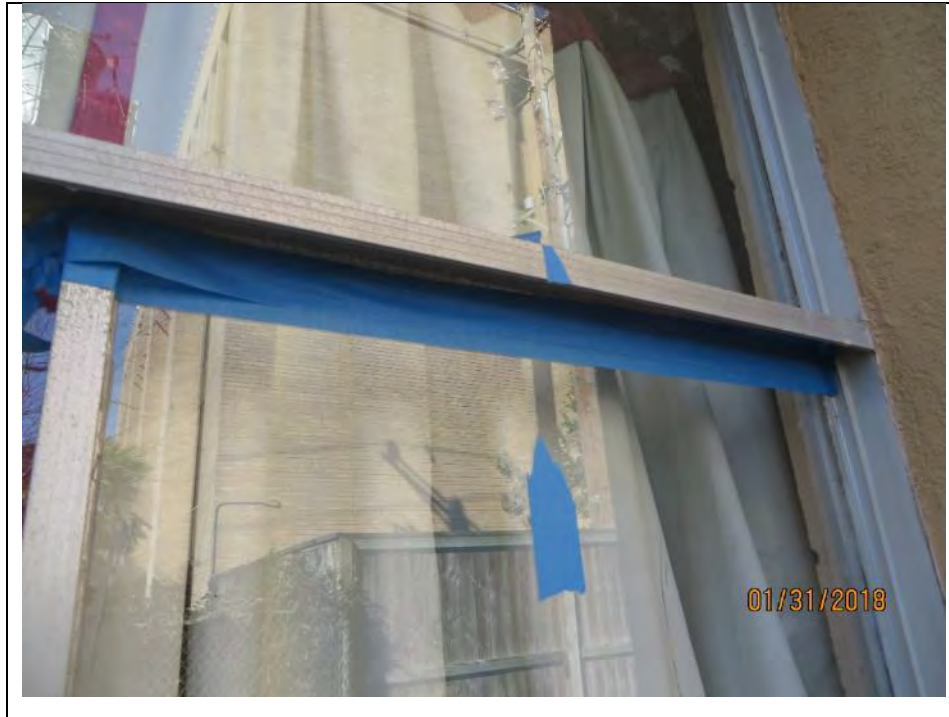
Figure 73. Window damage (KJS)

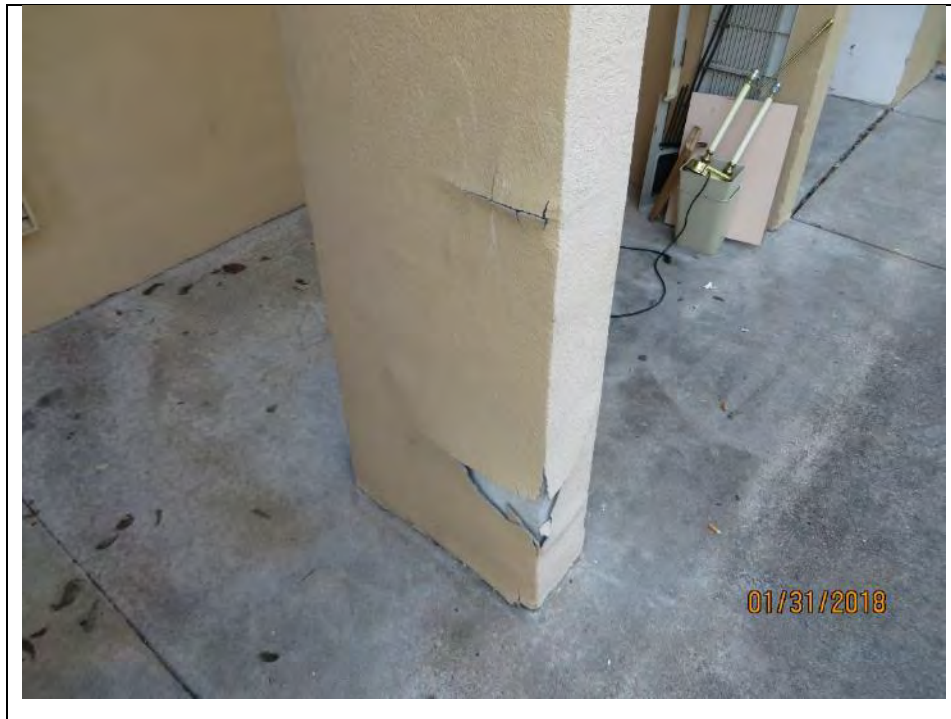
Figure 109. Stucco damage (KJS)

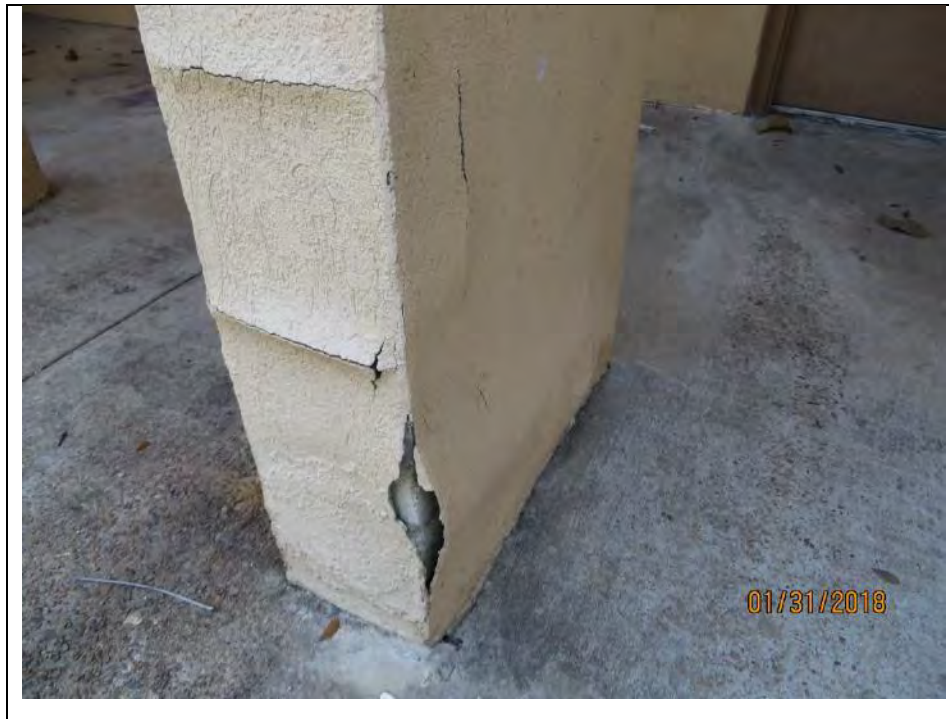
Figure 115. Damaged stucco (KJS)

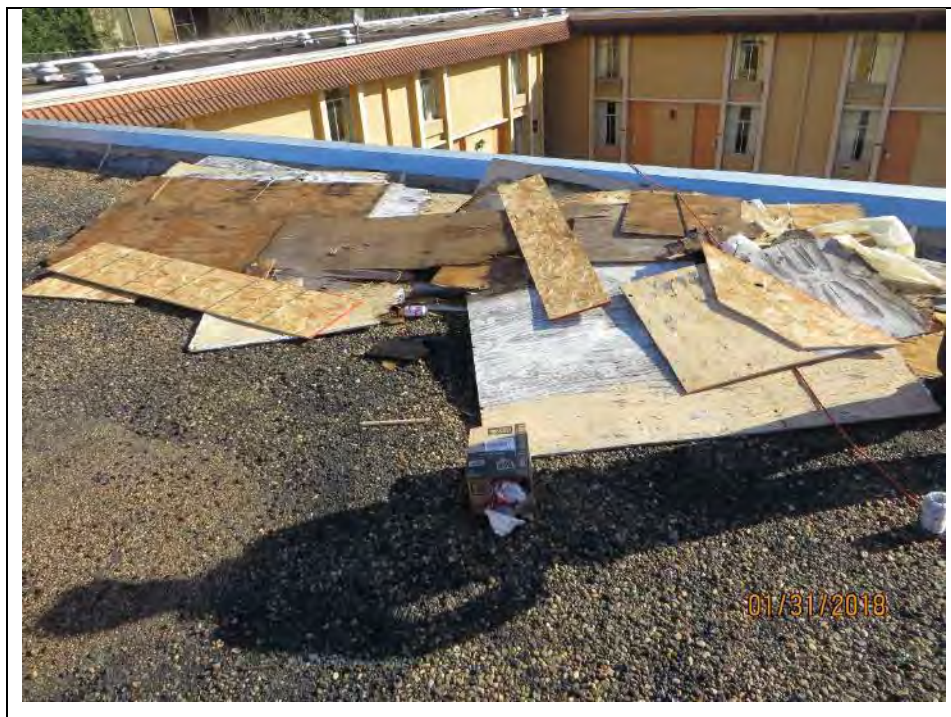
Figure 208. Temp repairs (KJS)

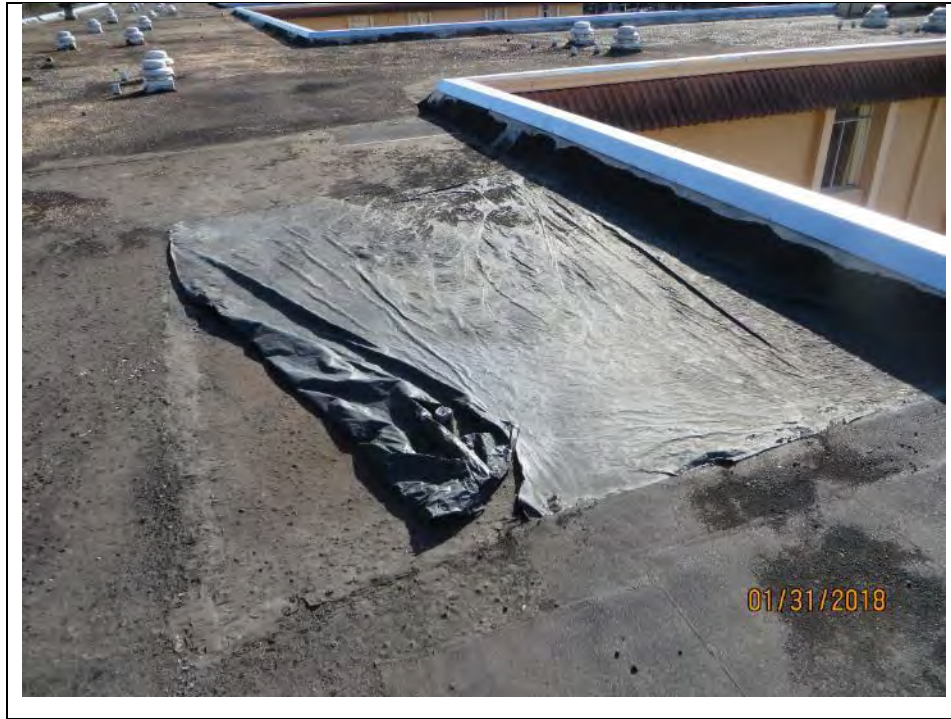
Figure 231. Temporary repair (KJS)

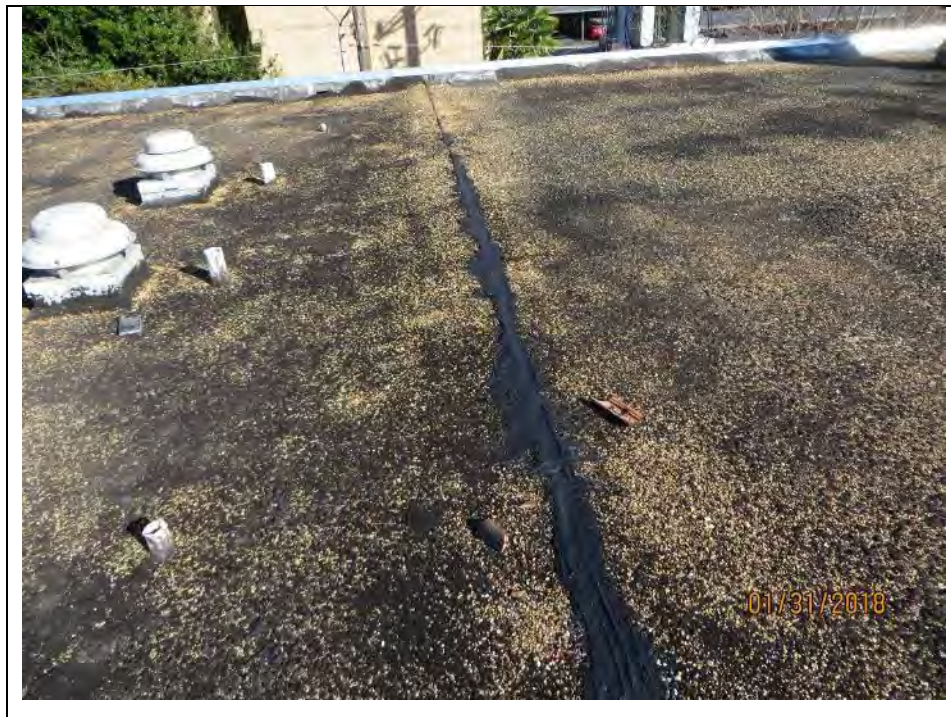
Figure 238. After storm repair (KJS)

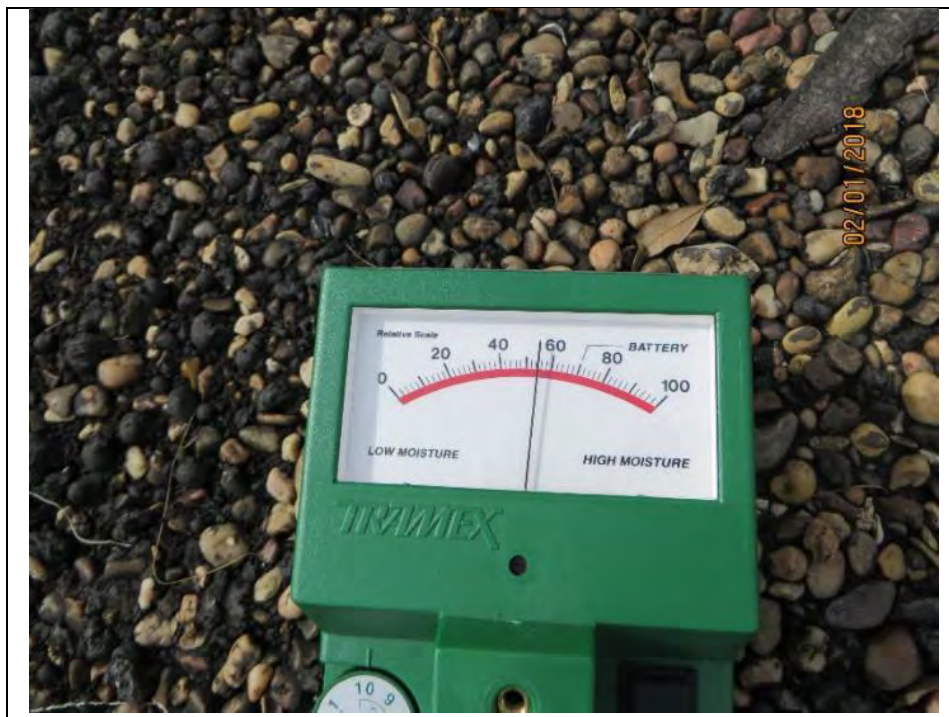
Figure 02. Elevated moisture (KJS)

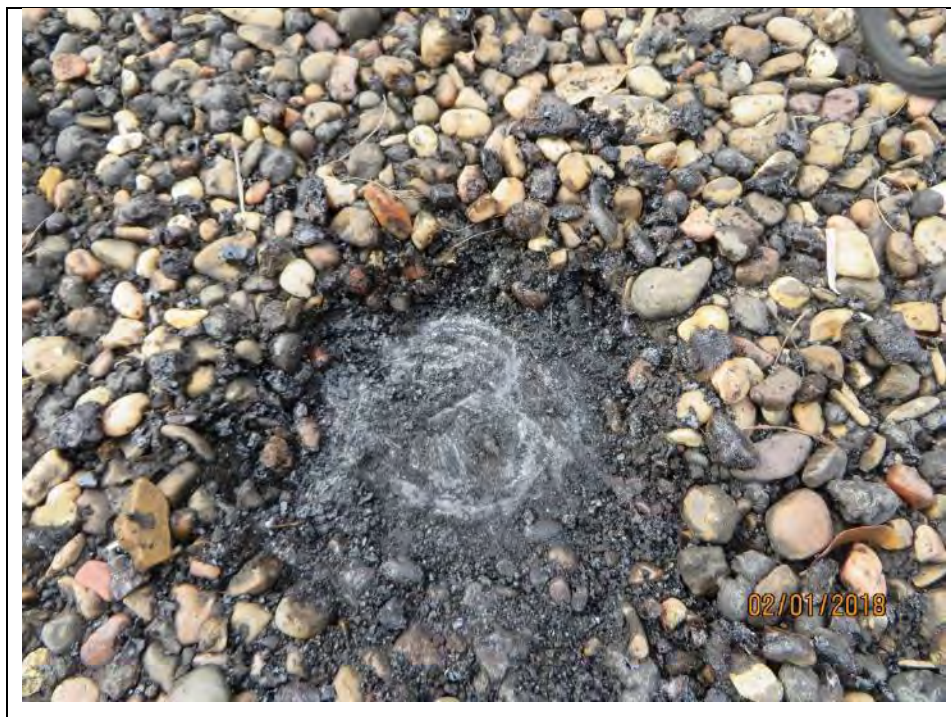
Figure 04. Core to be performed at location of high moisture reading. (KJS)

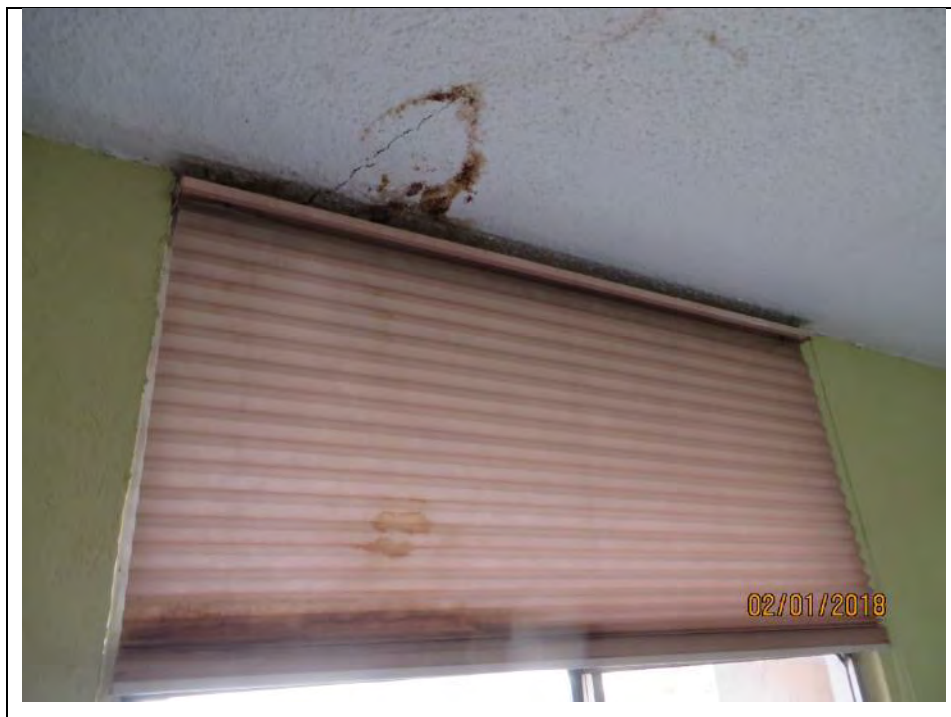
Figure 18. Typical water damage after storm (KJS)

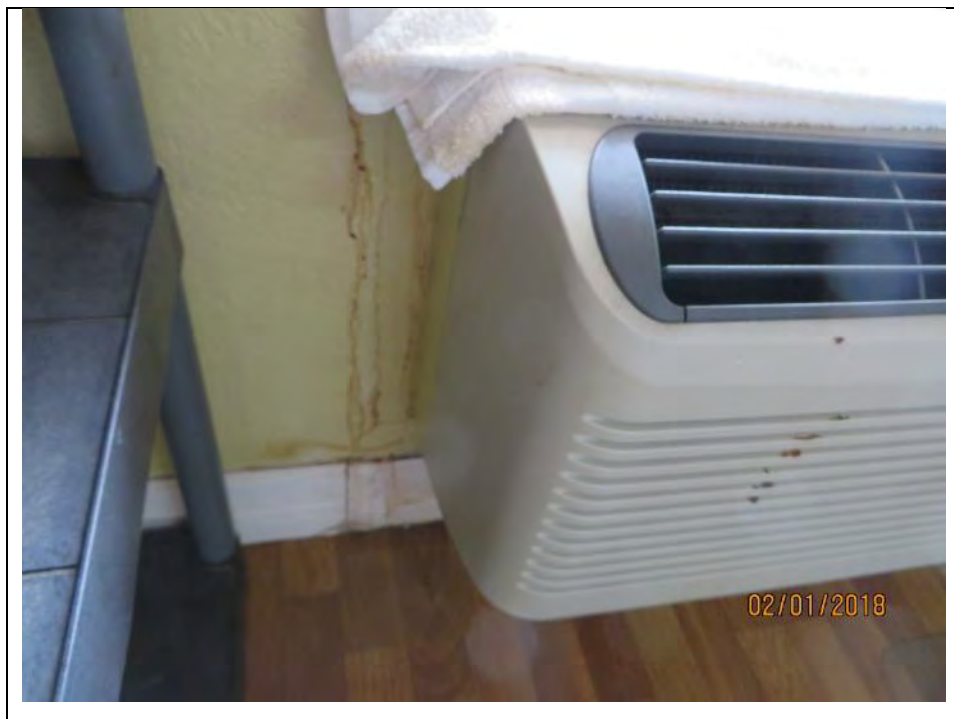
Figure 20. Typical water damage after storm (KJS)

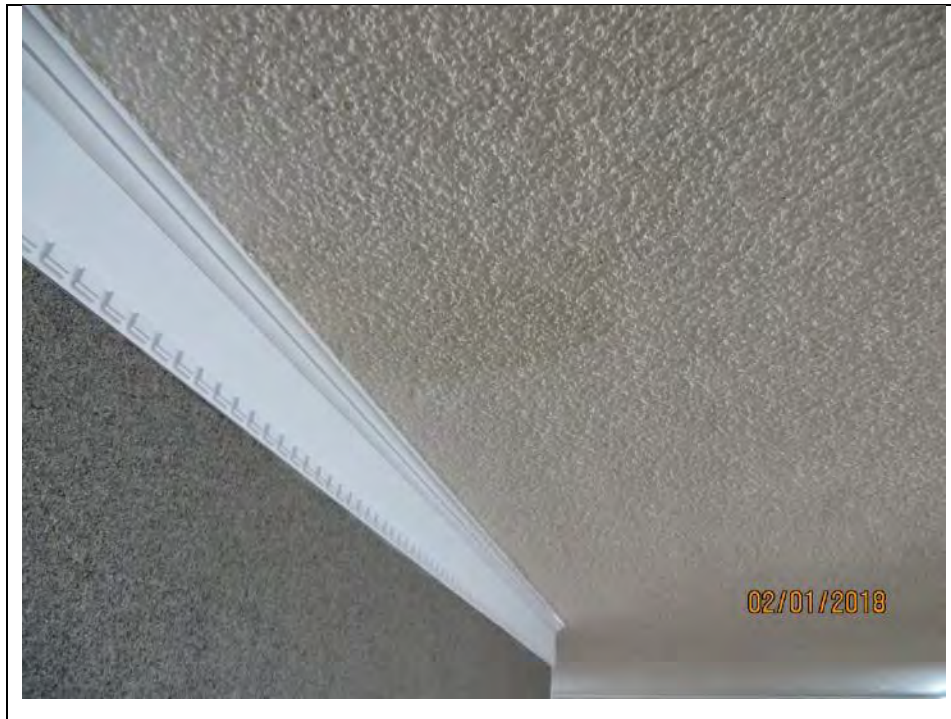
Figure 23. Typical water damage after storm (KJS)

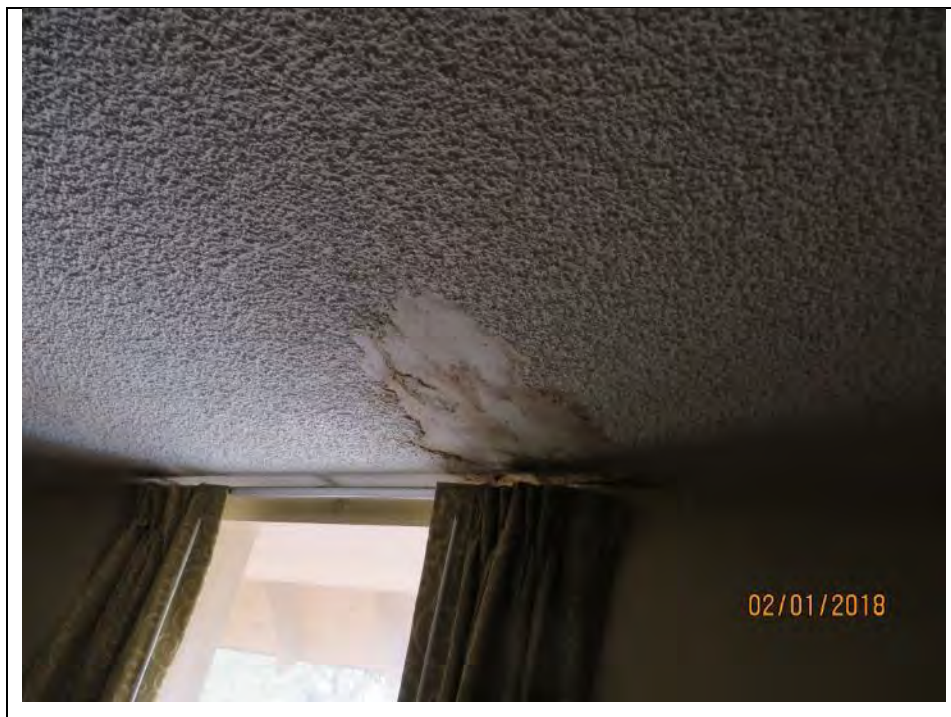
Figure 28. Typical water damage after storm (KJS)

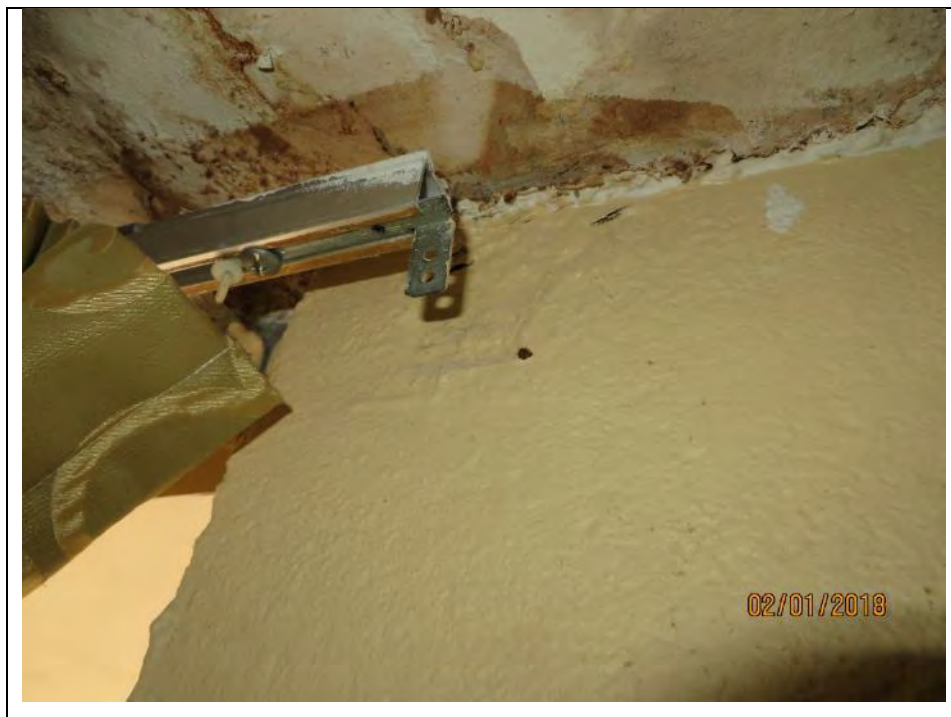
Figure 30. Typical water damage after storm (KJS)

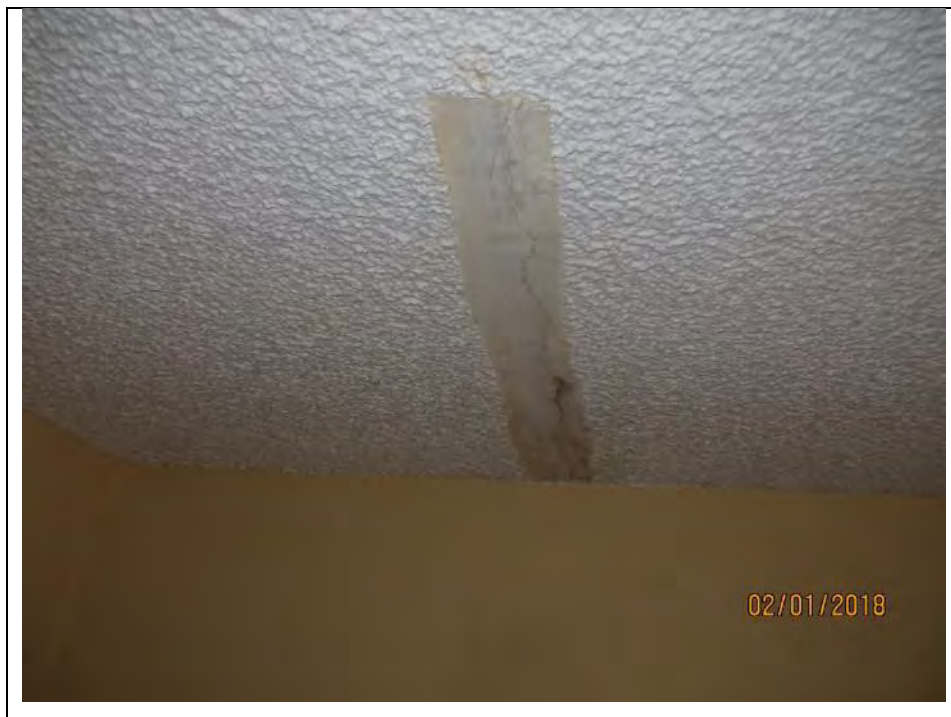
Figure 36. Typical water damage after storm (KJS)

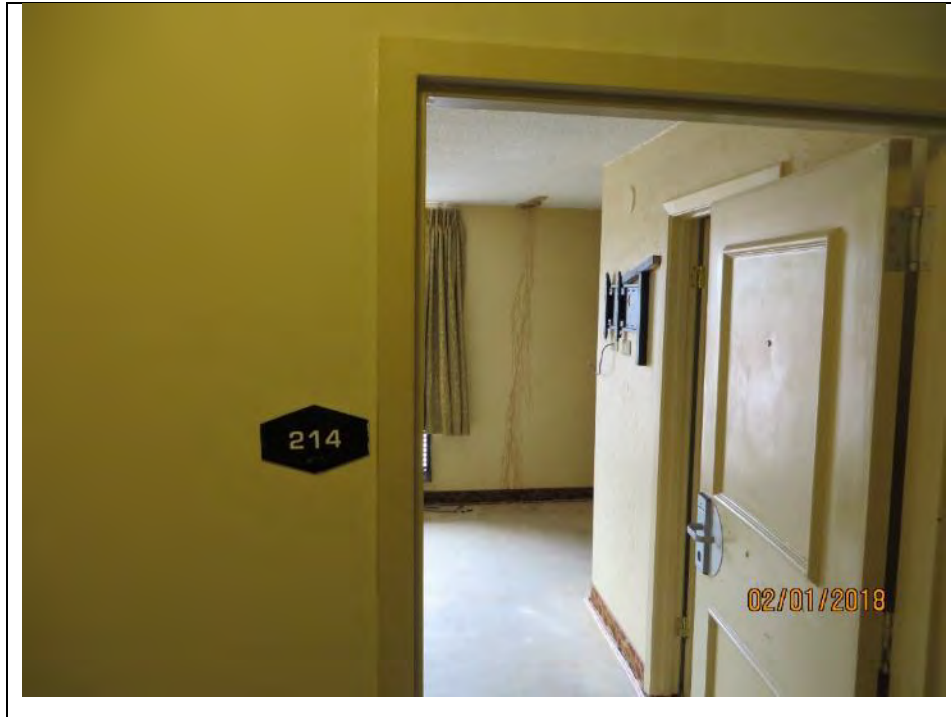
Figure 43. Typical water damage after storm (KJS)

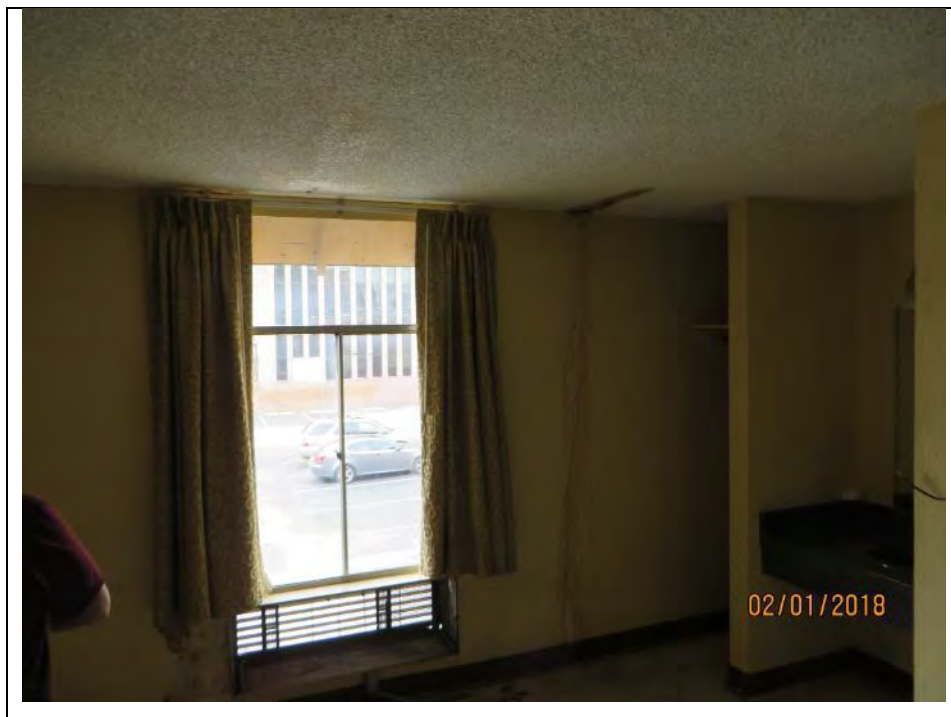
Figure 44. Typical water damage after storm (KJS)

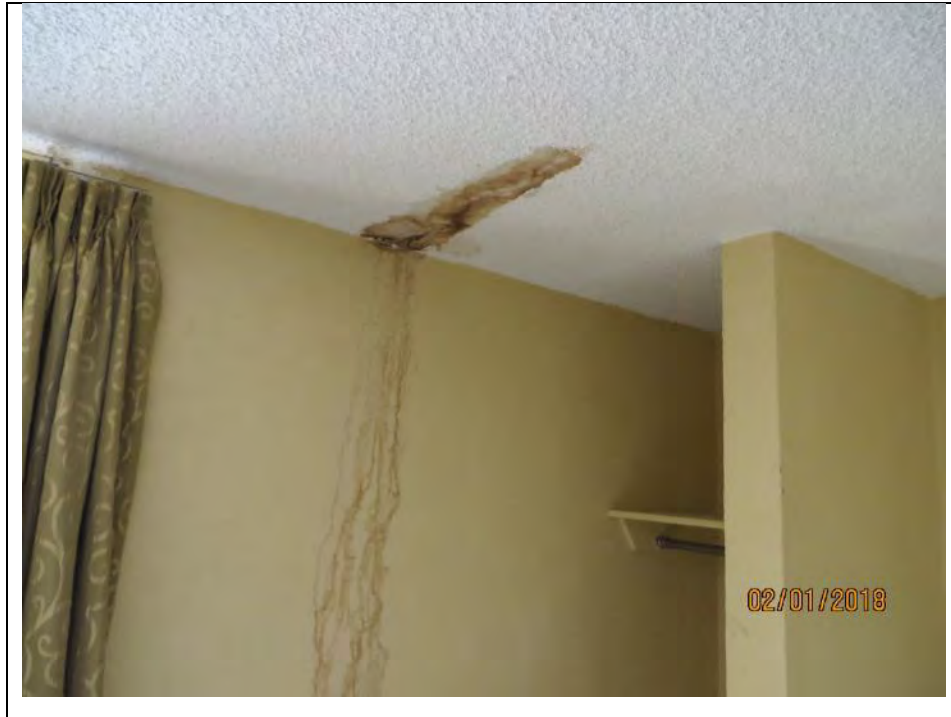
Figure 45. Typical water damage after storm (KJS)

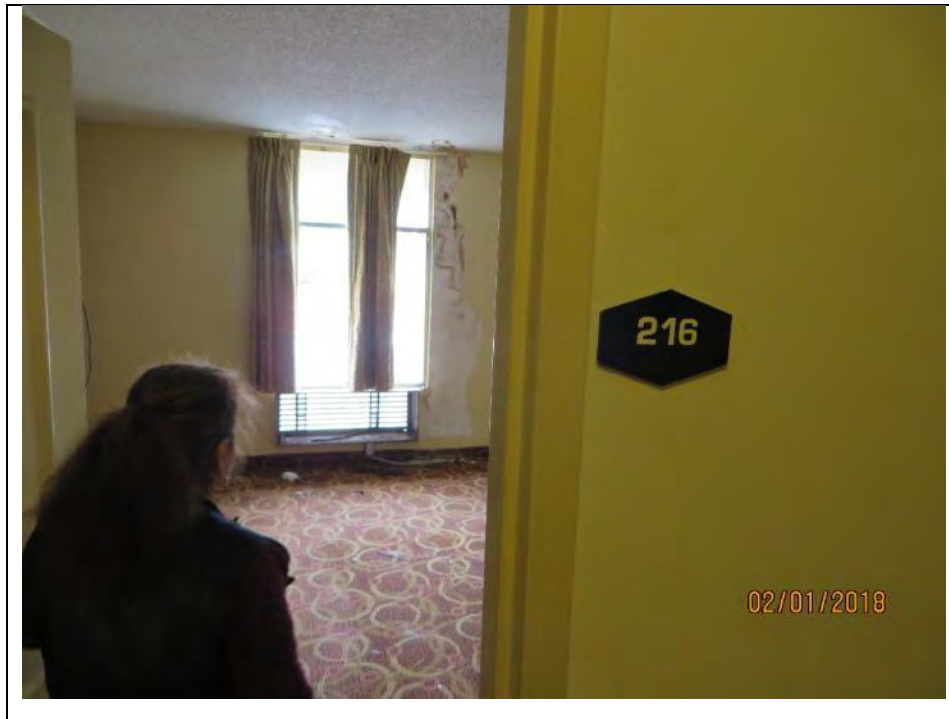
Figure 49. Typical water damage after storm (KJS)

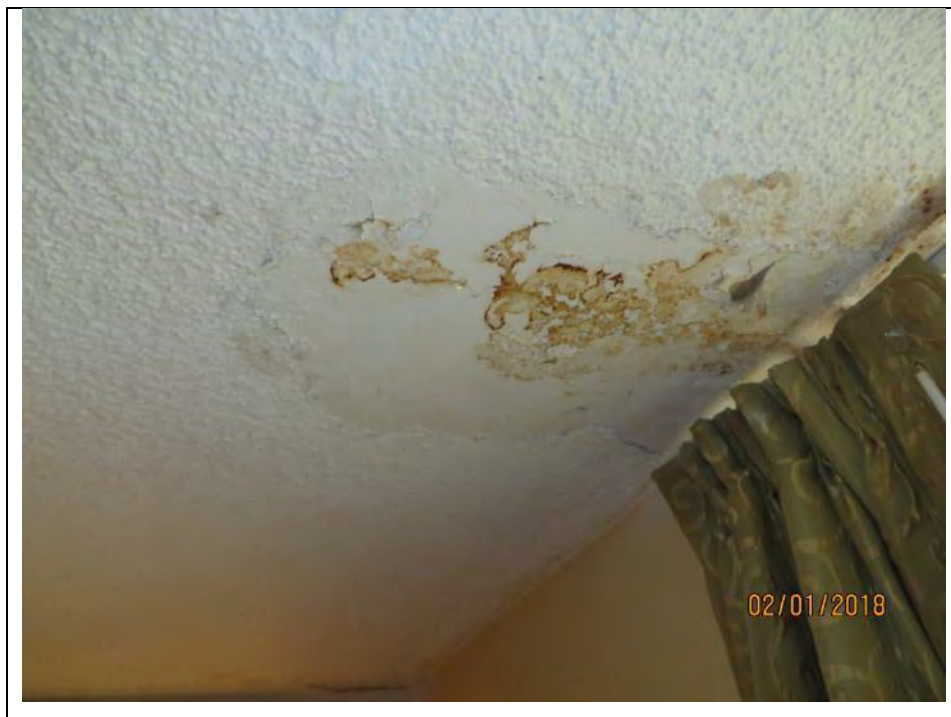
Figure 54. Typical water damage after storm (KJS)

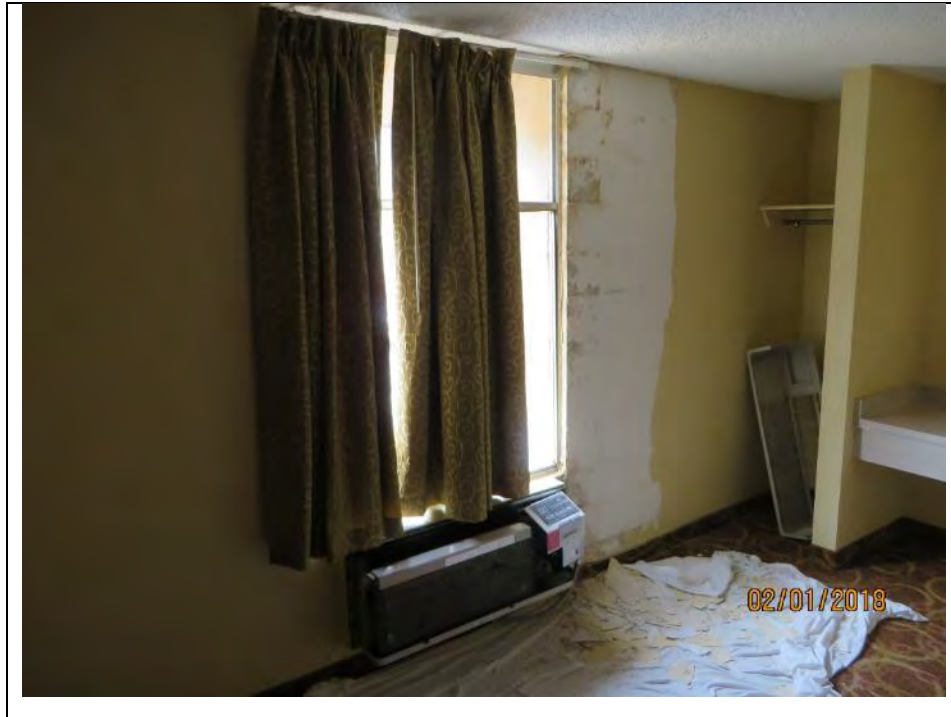
Figure 59. Typical water damage after storm (KJS)

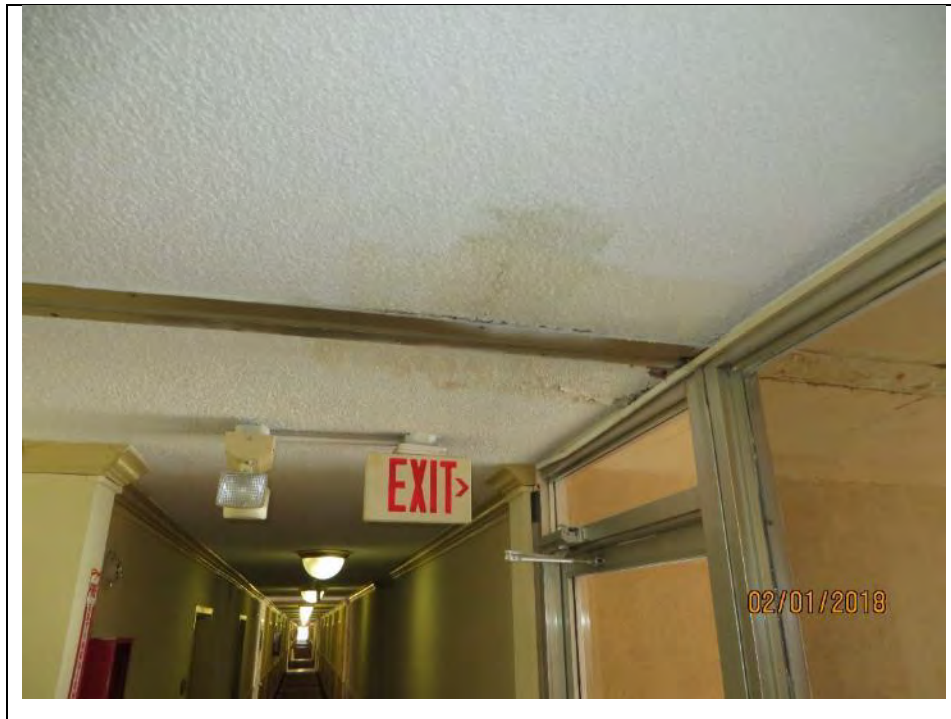
Figure 61. Typical water damage after storm (KJS)

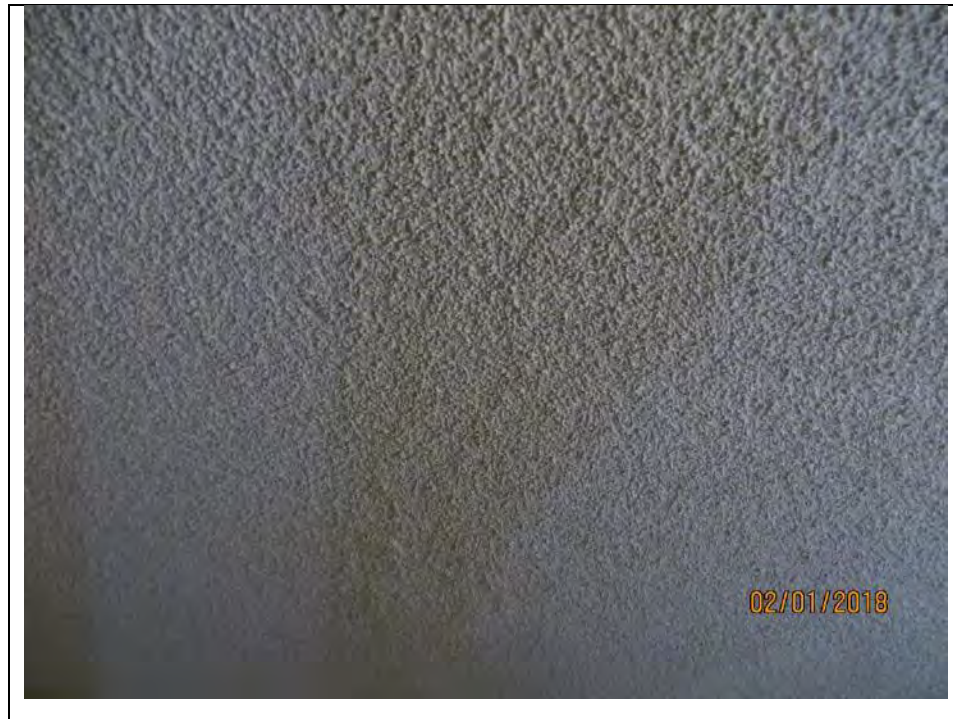
Figure 67. Typical water damage after storm (KJS)

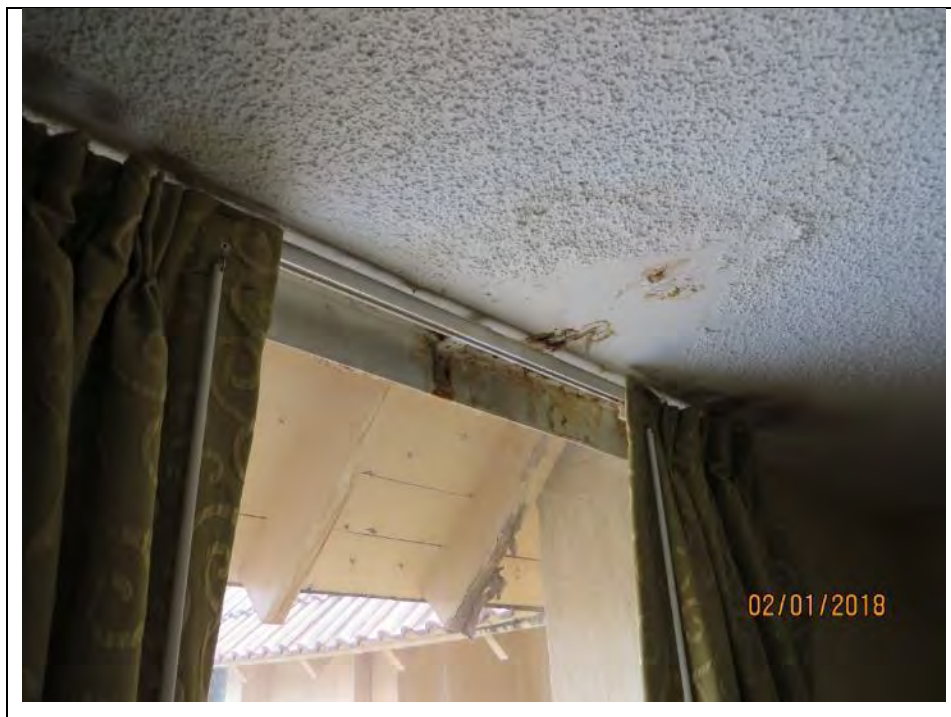
Figure 70. Typical water damage after storm (KJS)

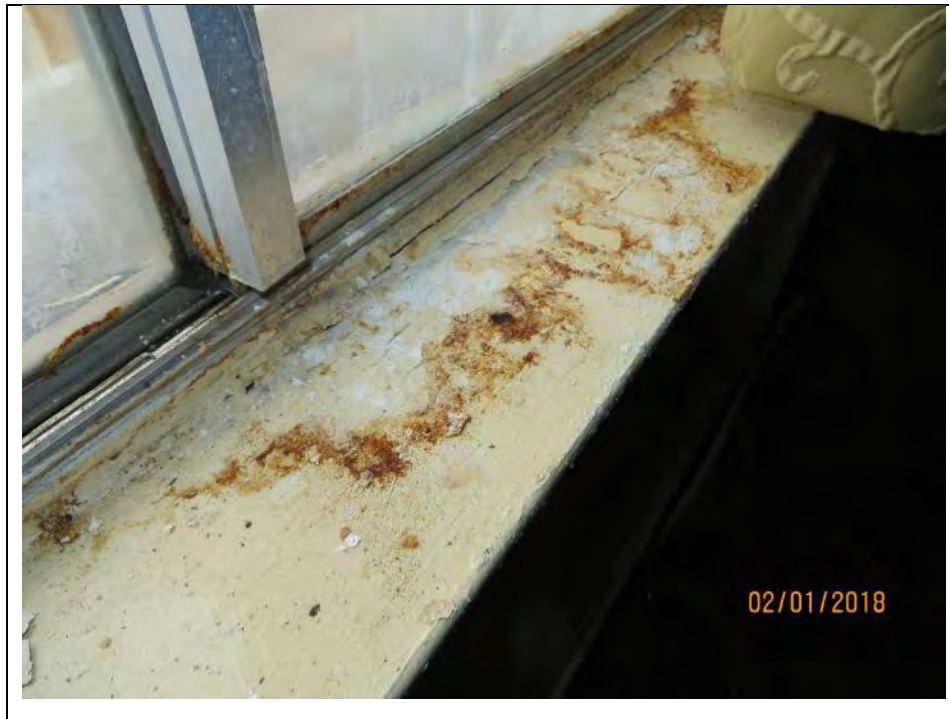
Figure 71. Typical water damage after storm (KJS)

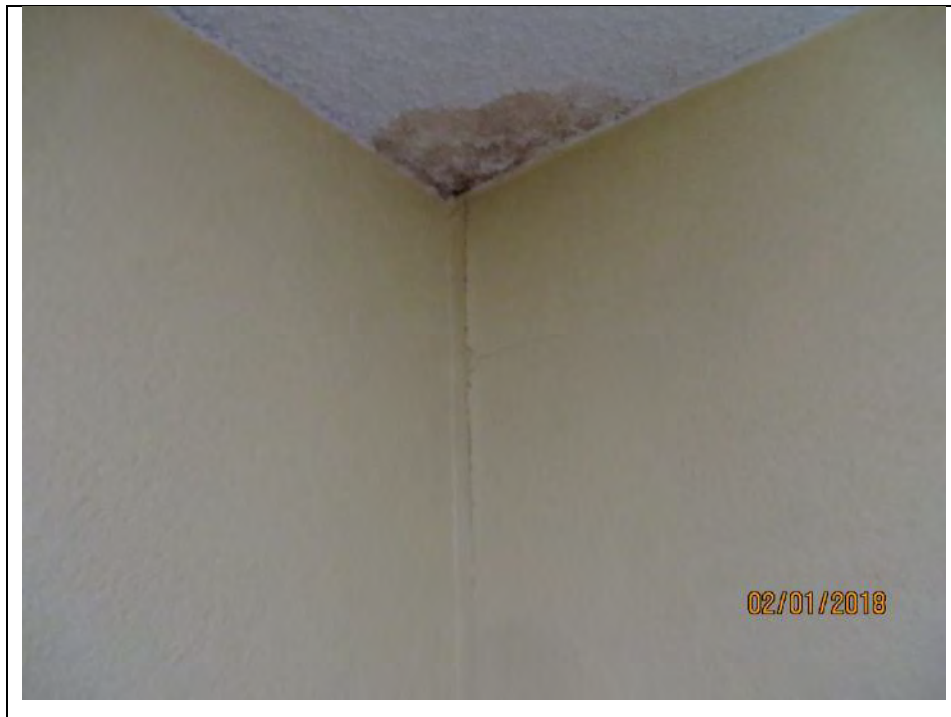
Figure 80. Typical water damage after storm (KJS)

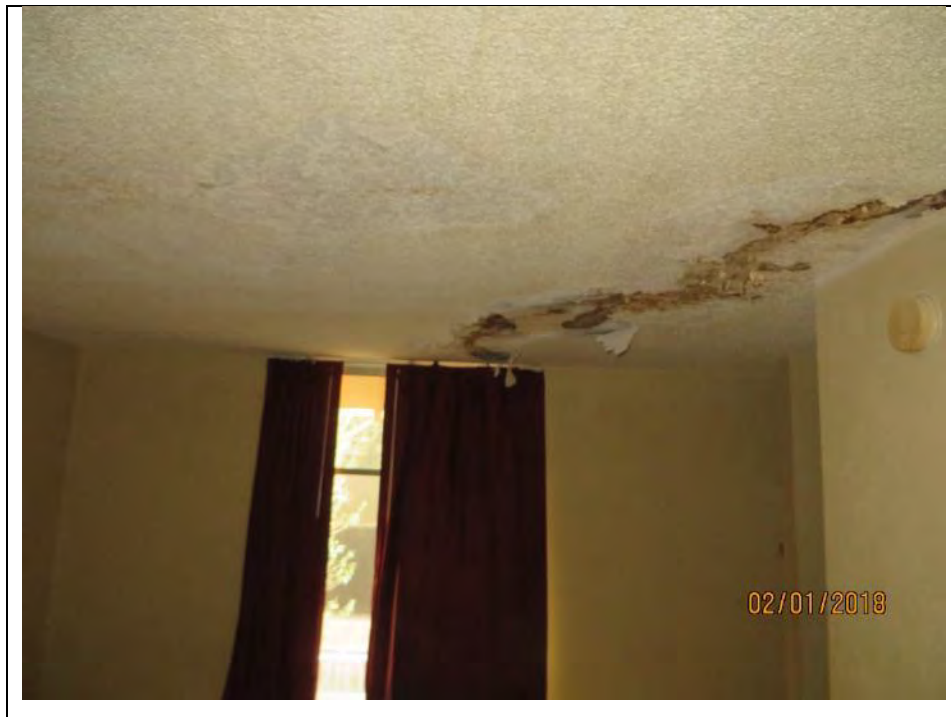
Figure 88. Typical water damage after storm (KJS)

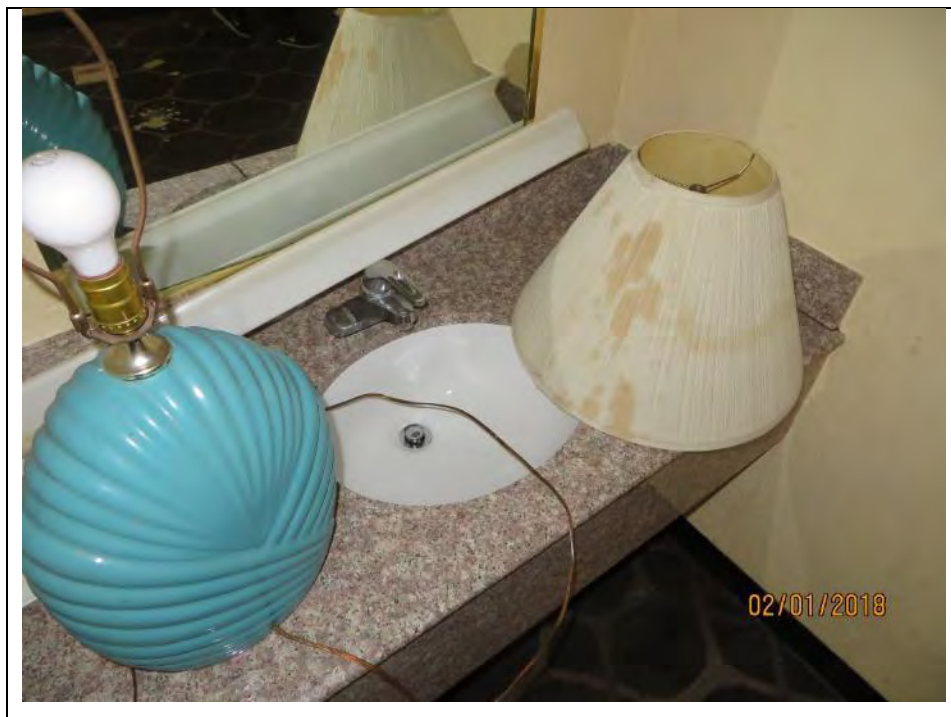
Figure 92. Typical water damage after storm (KJS)

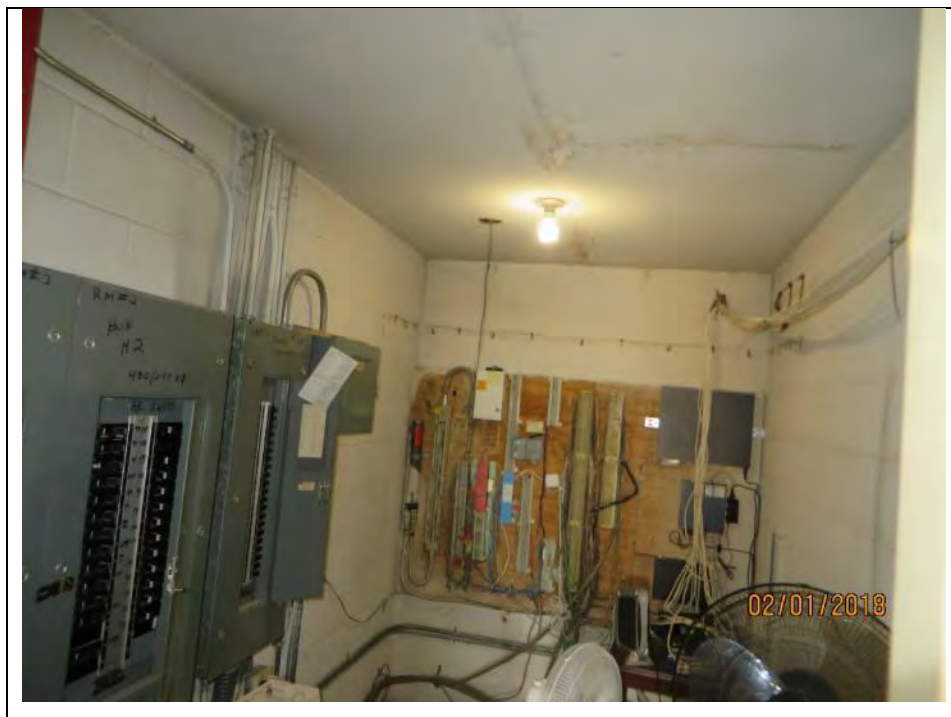
Figure 94. Typical water damage after storm (KJS)

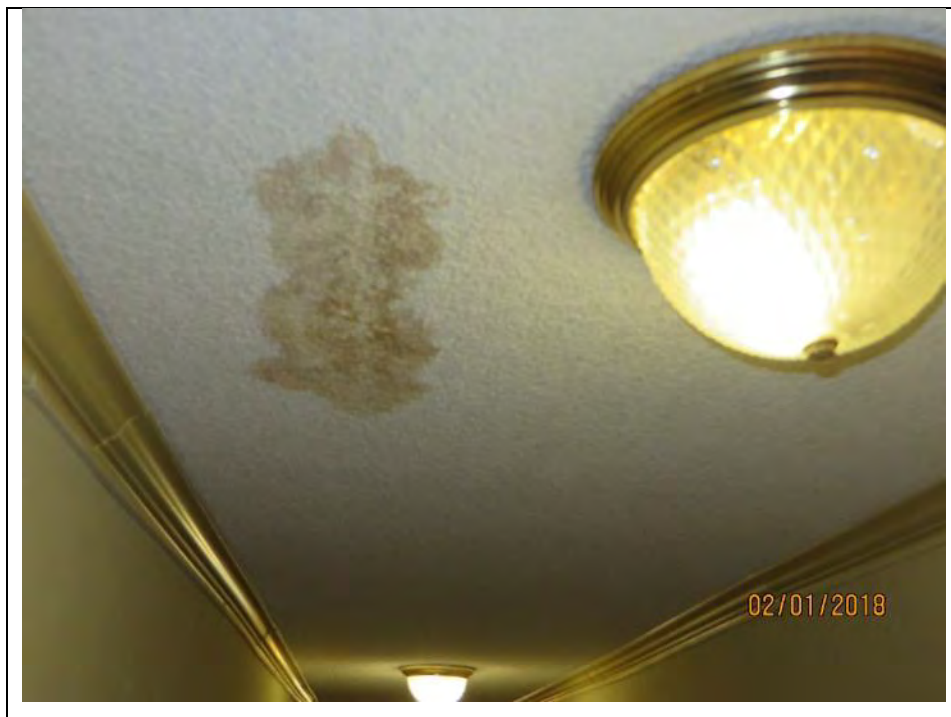
Figure 100. Typical water damage after storm (KJS)

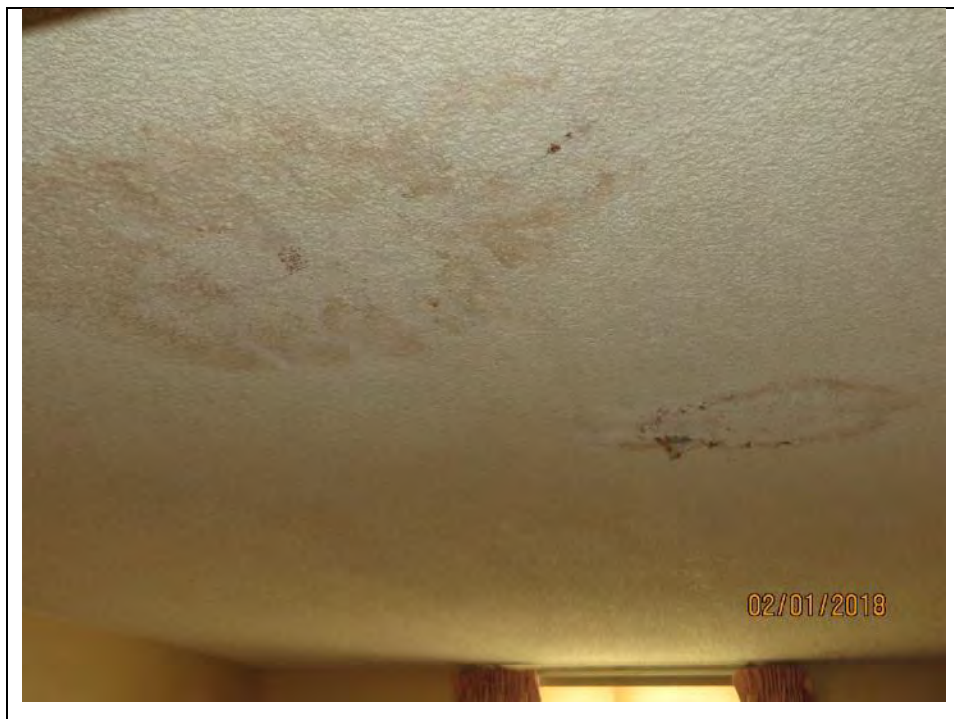
Figure 102. Typical water damage after storm (KJS)
